Reference No. 1314470516-025-L-Rev0

COLLIERY DAMS, NANAIMO BC LOWER DAM – DEVELOPMENT OF DESIGN ALTERNATIVES

This letter report summarizes the findings of studies carried out by Golder Associates Ltd. (Golder) for the City of Nanaimo (City) on the Lower Colliery Dam in Nanaimo BC. These studies, carried out principally in May 2015, were primarily related to further development of flood routing remediation options for the Lower Dam. The remediation options that were to be evaluated were drawn from a list of options identified by the Province of BC, which formed part of the basis of an Order for remediation of the Colliery Dams (BC 2015). This letter report documents additional work that has been carried out on two of the options identified in the Province of BC letter, namely, the Overtopping Option, and the Auxiliary Spillway Option. A general arrangement of the Lower Dam, the existing spillway and the proposed auxiliary spillway location are shown on Figure 1.

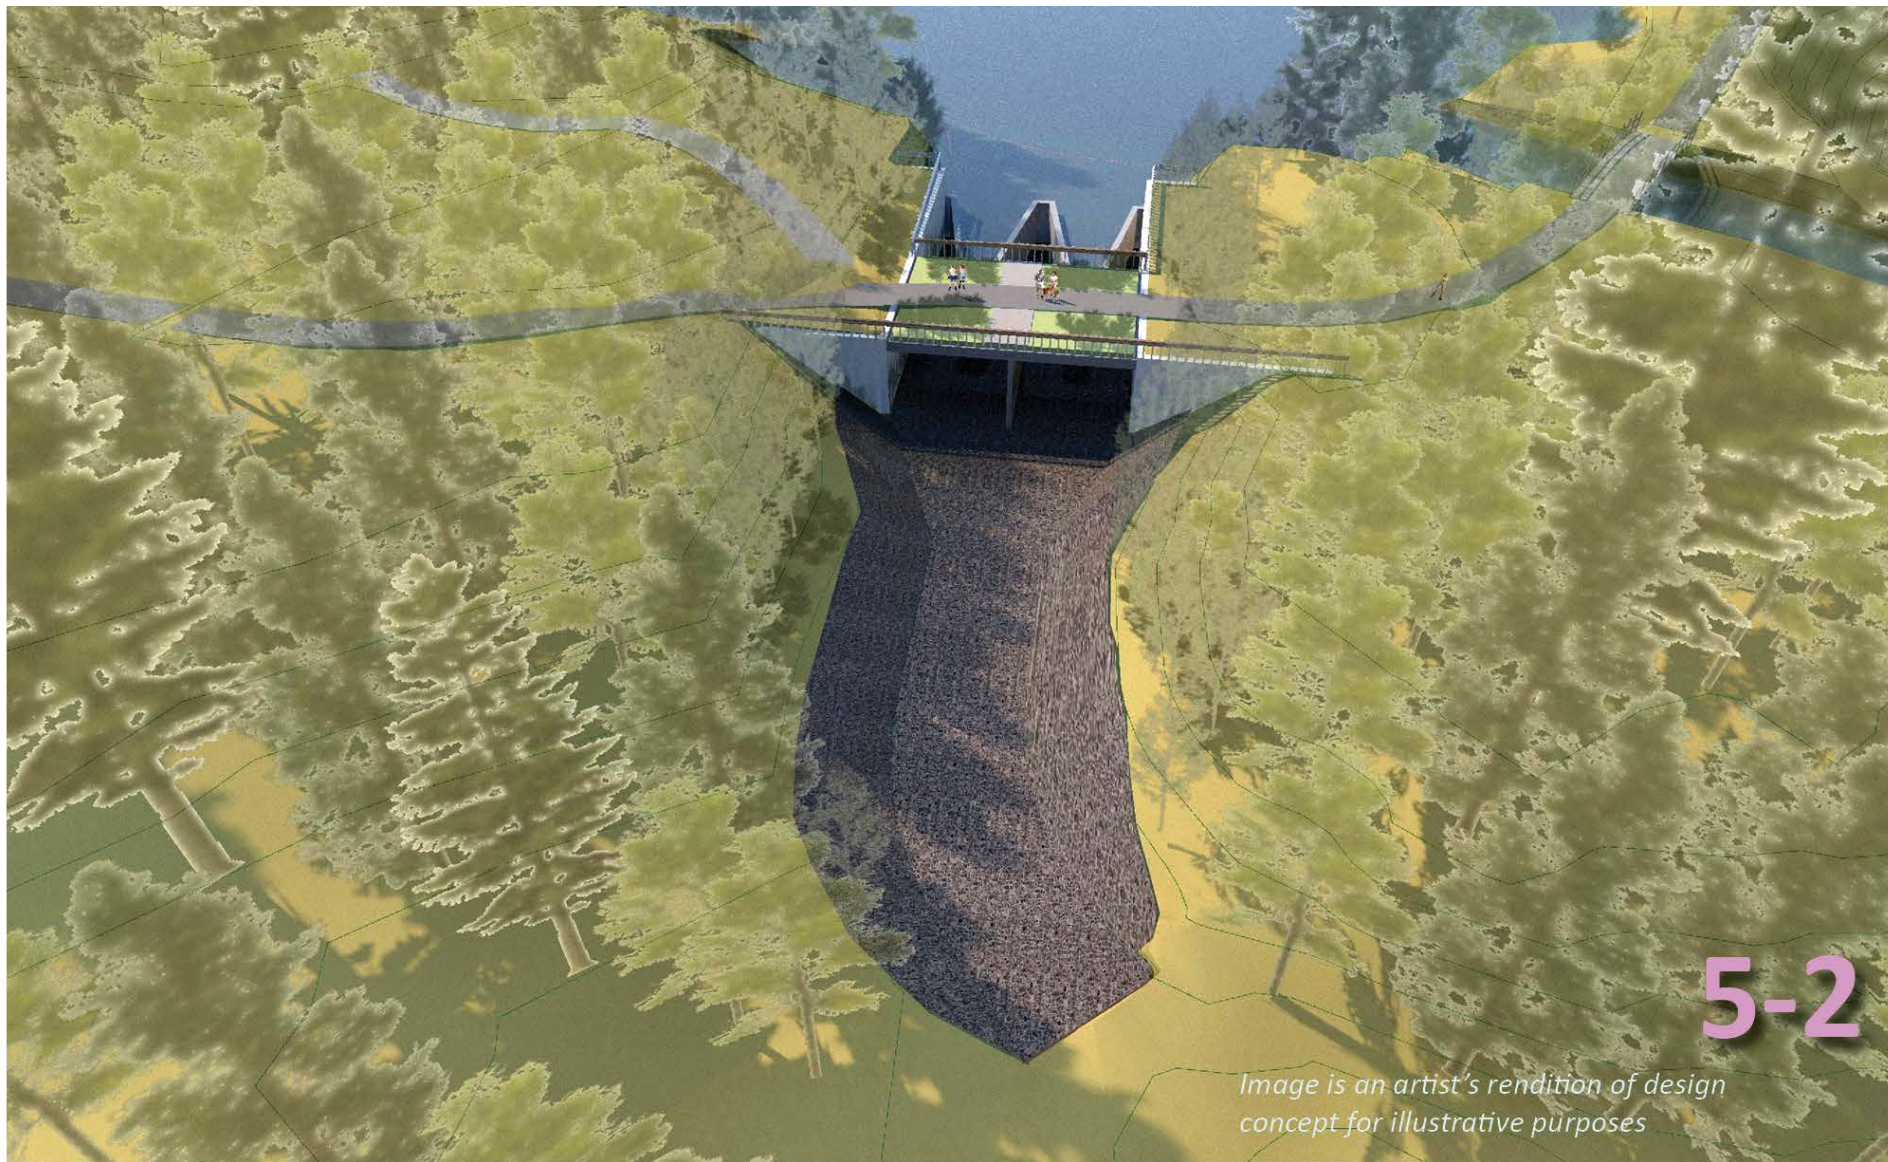
PROJECT No.	1314470516	PHASE No. 3000
	DESIGN	DC 24 June 15	SCALE: NTS REV.
	CADD	----	
	CHECK	JG 25 June 15	
REVIEW	BD 03 July 15		Figure D-8

Image is an artist's rendition of design concept for illustrative purposes

Areal view from the south

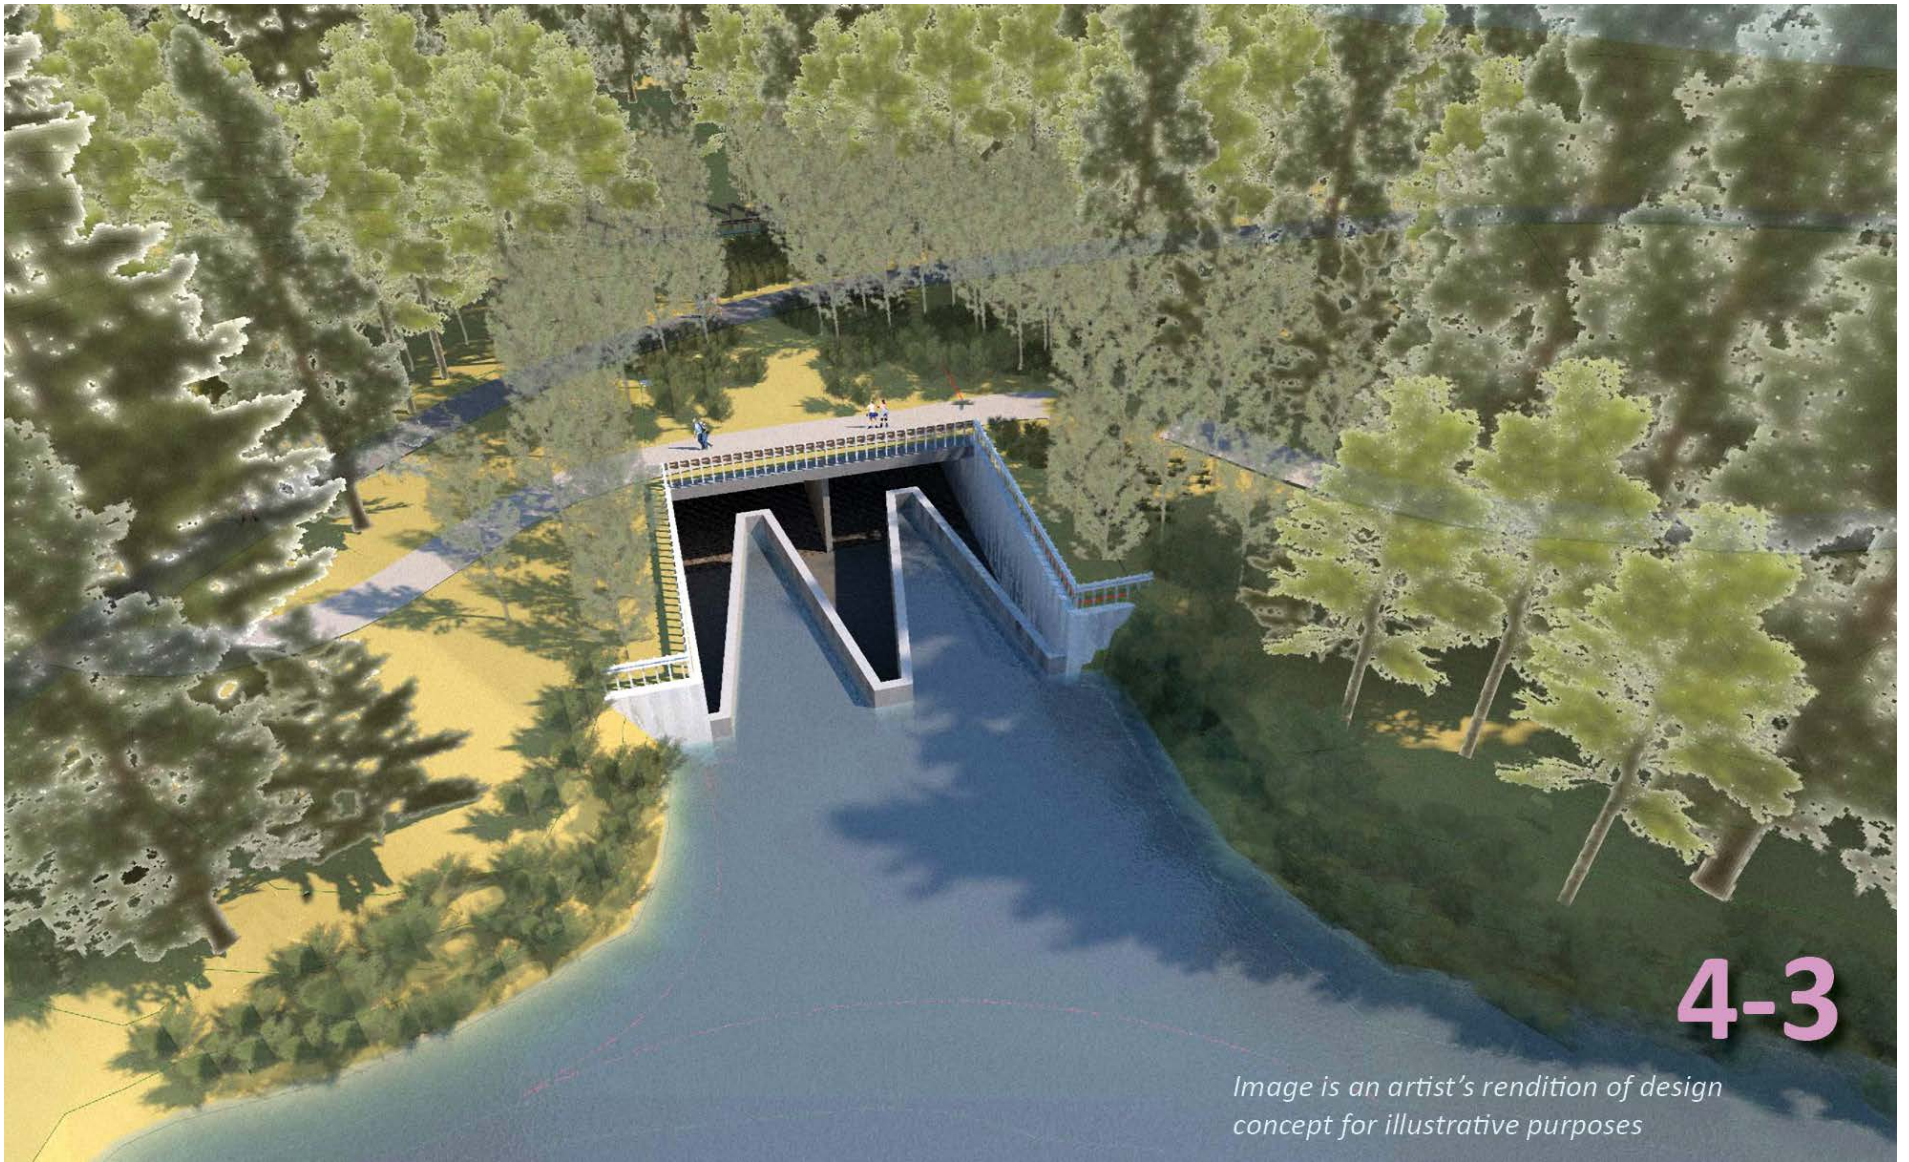
PROJECT No.	1314470516	PHASE No. 3000
	DESIGN	DC 24 June 15	SCALE: NTS REV.
	CADD	----	
	CHECK	JG 25 June 15	Figure D-9
REVIEW	BD 03 July 15

Areal view from the north

PROJECT	Colliery Dams Nanaimo, BC			
TITLE	Auxiliary Spillway to Harewood Creek Buried Channel Option 3

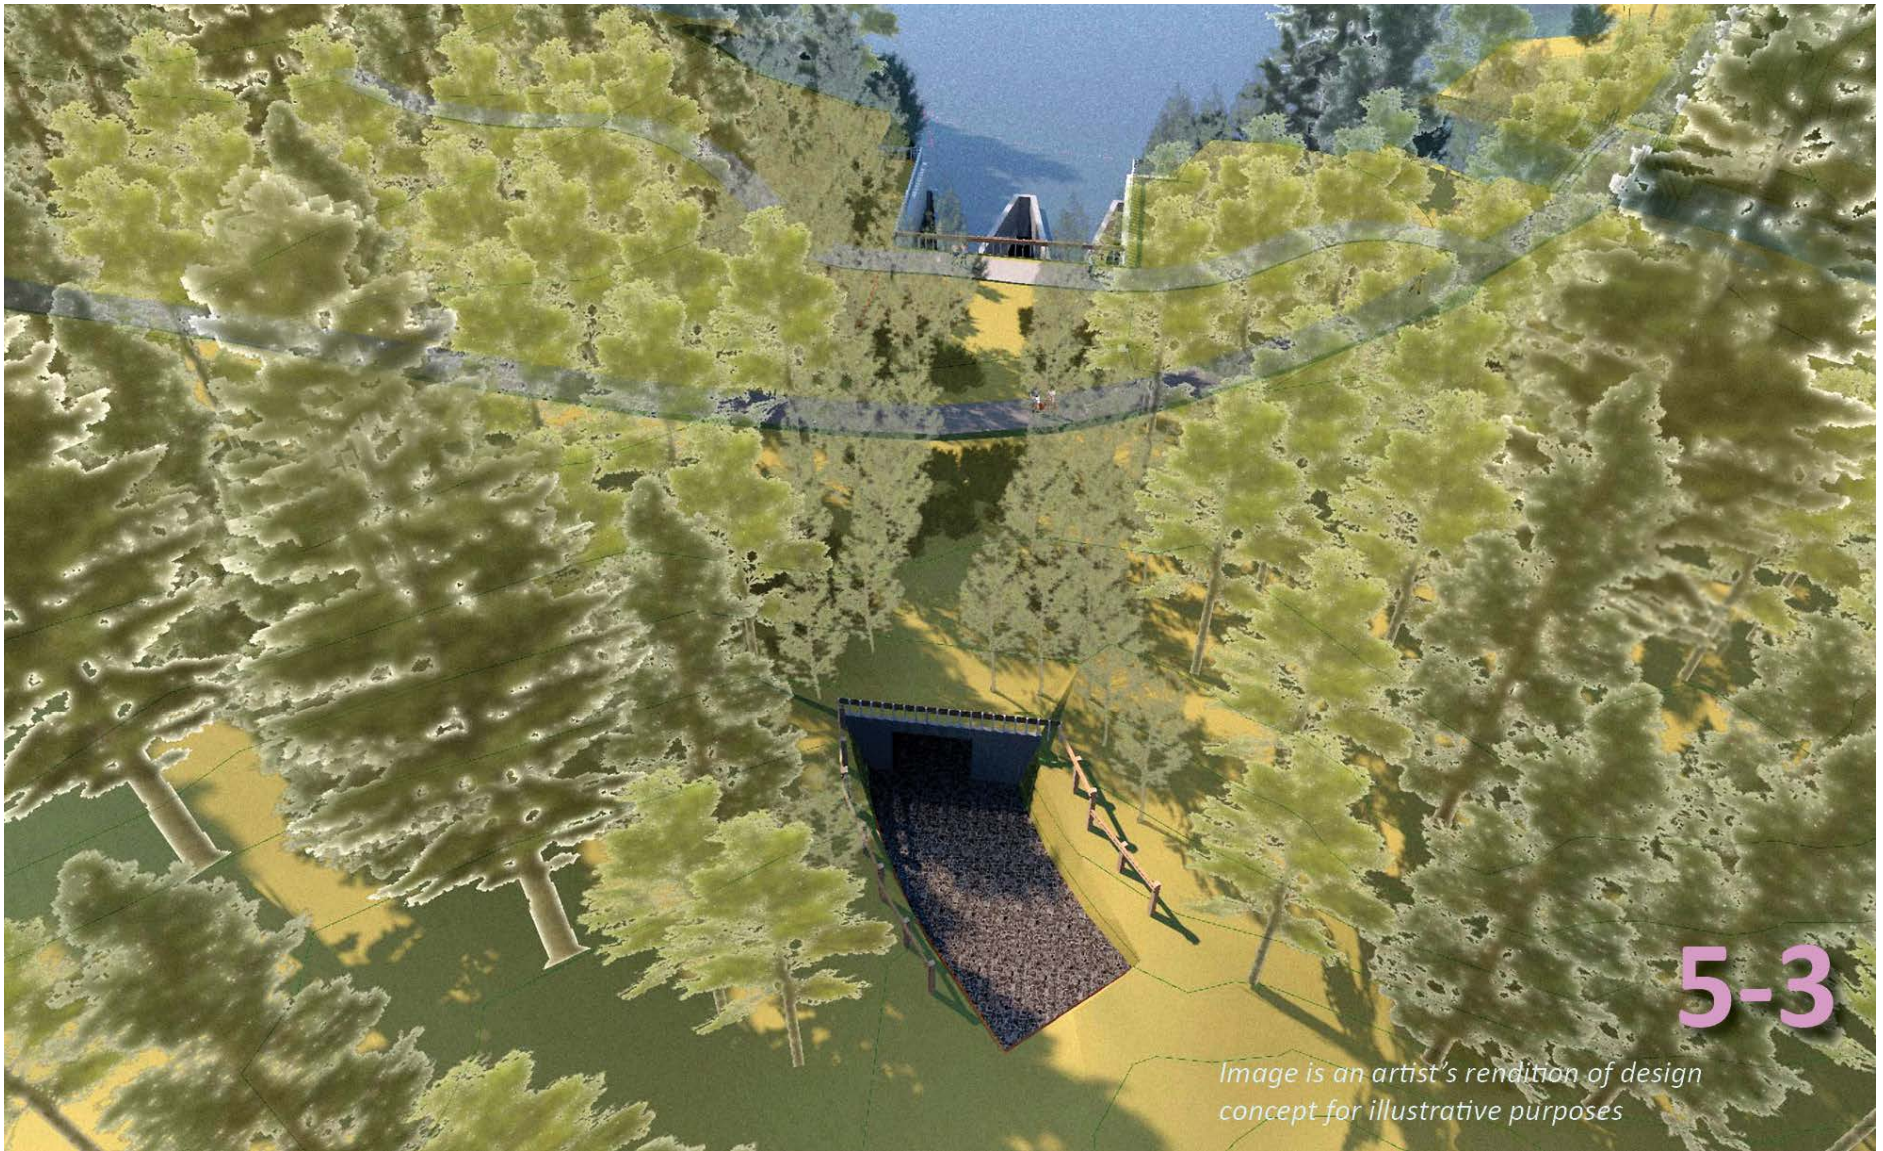
PROJECT No.	1314470516	PHASE No.	3000
	DESIGN	DC	24 June 15	SCALE: NTS
	CADD	----	----	REV.
	CHECK	JG	25 June 15	Figure D-10
REVIEW	BD	03 July 15

Image is an artist's rendition of design concept for illustrative purposes
